# REPAIR AND SEISMIC STRENGTHENING OF HISTORIC BUILDINGS AND MONUMENTS

Predrag Gavrilovic i Veronika Sendova<sup>1</sup>

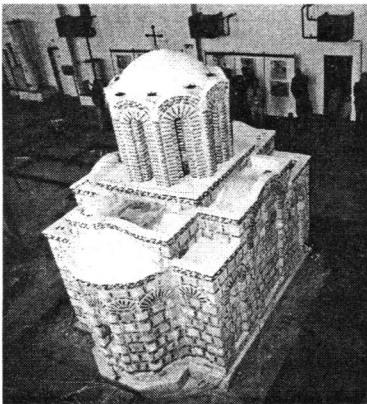
*M-SN-EXIST*

*M-SN-STR*

*Figure 4. Models on shaking table*

A model of St. Nikita church selected as representative church, was constructed to a scale of 1 : 2.75 and tested on a seismic shaking table simulating the existing and the strengthened state, (Figure 4) to investigate the linear behaviour, nonlinear behaviour, and behaviour in the heavily damaged state (close to failure). The applied methodology for repair and strengthening is in compliance with the principle of "minimum interventions - maximum protection" and increases the bearing capacity and deformability of the structure up to the level of the designed protection.
